Manhole Inspection Summary

Manhole # S41SS_016MH

Insp Date: **2/19/07 8:03 AM**

Location Address: **2601 KIRK AVE**

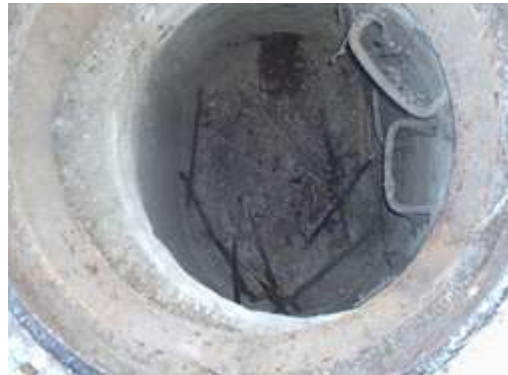
Top View

Infiltration: ☐ None ☒ **Joint** ☐ Cracks ☐ Mortar ☐ Roots ☐ Wall

Infiltration: ☐ None ☐ Joint ☐ Cracks ☐ Mortar ☐ Roots ☒ **Wall**

☒ **Debris** (not Condition related)

Adjustment and Barrel infiltration.
Channel debris.

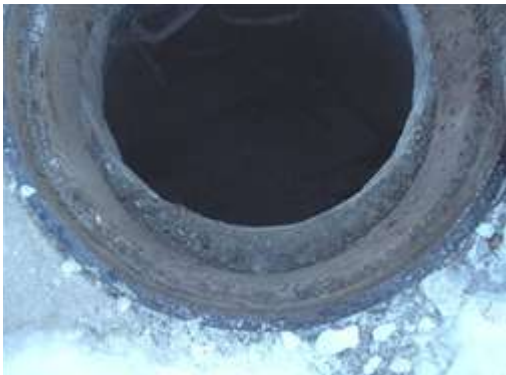
Defect

Offset: **3** (in.)

☒ **Leaks**

Frame leaks. Frame offset.

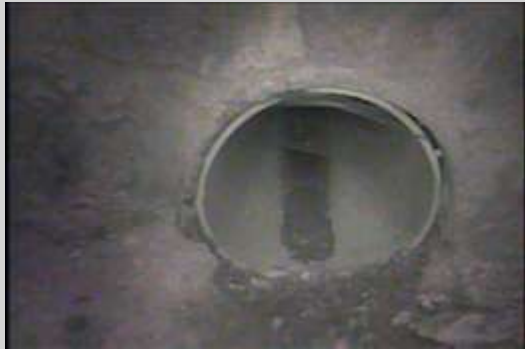
8 in. Circular Gravity Sewer
Pipe Out @ 12 O'Clock

Deposits: ☐ None ☒ **Mud** ☐ Sludge ☒ **Debris** ☐ Grease

Deposits Extent: **Light**

Infiltration: **Evidence**
